Hydrology, Hydraulics, and Sediment Studies for the Foster Park Well Design - DRAFT Report

Matilija Dam Ecosystem Restoration Project, Ventura, CA

**U.S. Department of the Interior
Bureau of Reclamation
Technical Service Center
Denver, Colorado**

May 2007

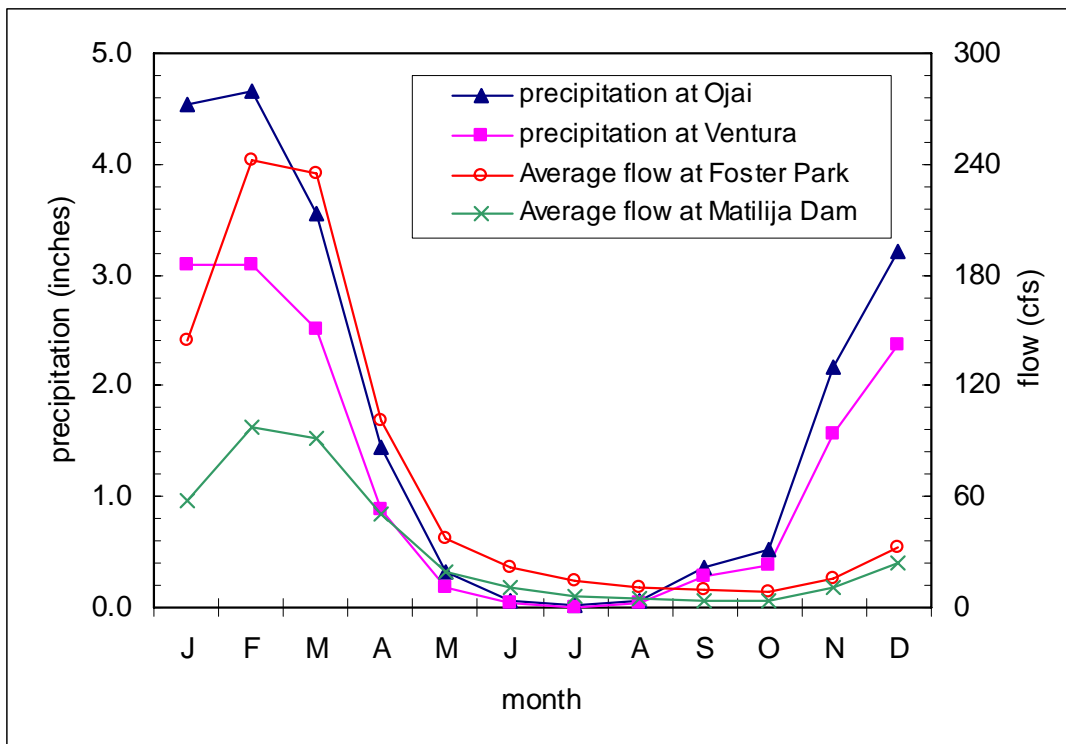
There is extreme seasonal variation in the rainfall and over 90% of the rainfall occurs during the six months between November and April (Figure 3). The source of the rainfall data is the National Climatic Data Center (NCDC, <http://lwf.ncdc.noaa.gov/oa/ncdc.html>) rain gages in the cities of Ventura and Ojai. The period of record was from as early as 1874 until as late as 1995. The flows in the river show the same trend, but lag in time. This lag is due to the storage capacity of the soil in the watershed.

Figure 3. Seasonal variation of average rainfall and flow in Ventura River Watershed.

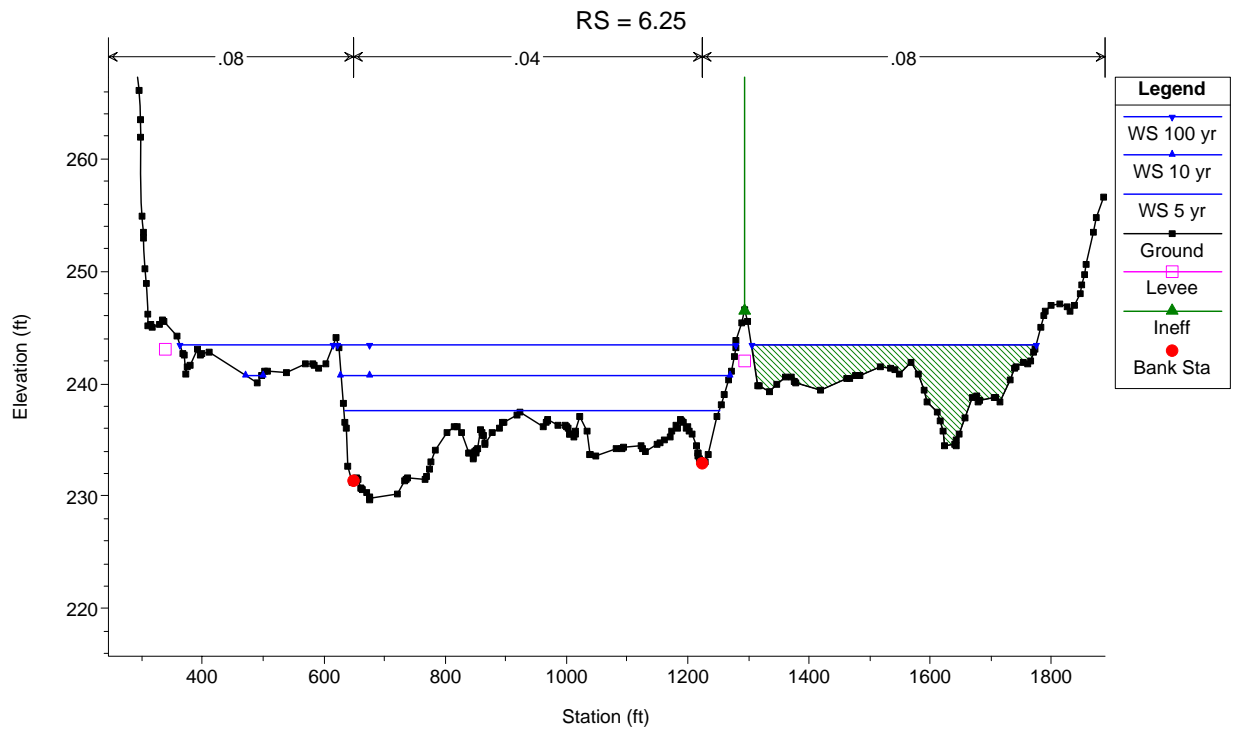
Plots of the cross section immediately downstream and upstream of the wells are shown in Figure 6 and Figure 7, respectively. The hydraulic data calculated from HEC-RAS for the 10-yr, 50-yr, 100-yr, and 500-yr flood is given in Table 3 through Table 6 for cross sections near the wells.

Figure 7. Cross section at RM 6.250.

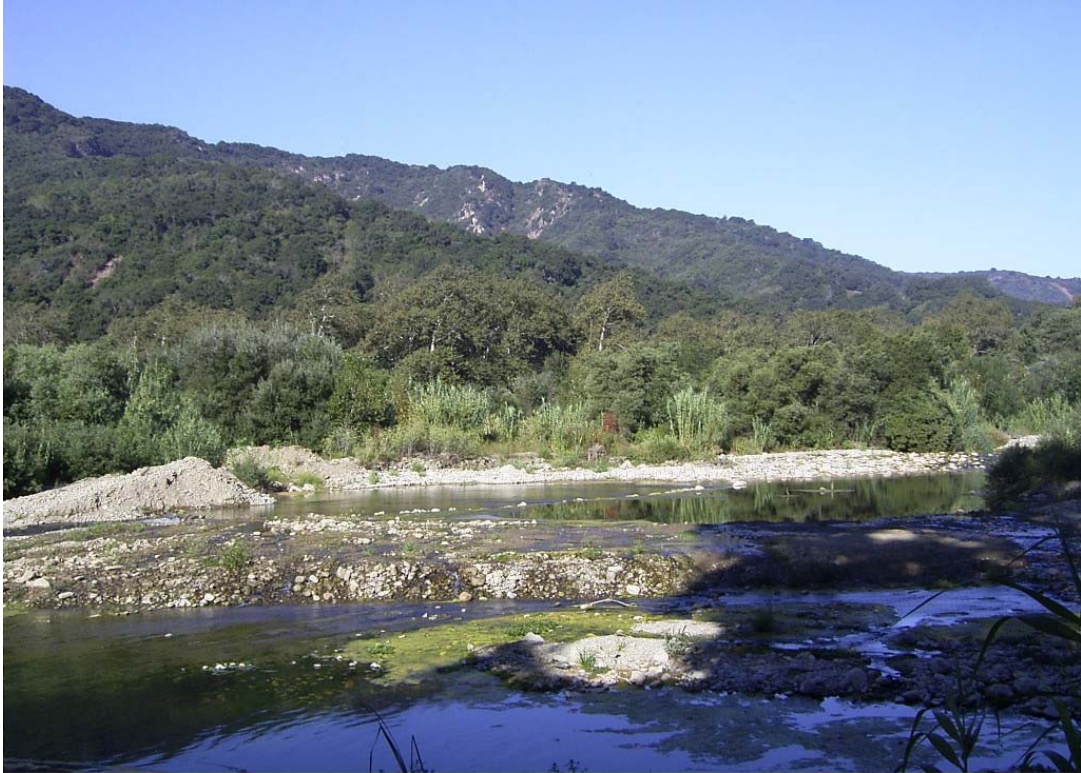
Figure 8. Picture Looking Across River from Downstream Well.

The river channels in the reach upstream of RM 6 are active and frequently change location. Section 12 “Appendix B: Historical Aerial Photographs” contains the aerial photographs of the reach in 1947, 1970, 1978, 2001, and 2005. In 1947, the active channel was narrower with more woody vegetation. By 1970, the active channel was much wider and there was evidence of channel excavation and straightening. The 1969 flood was one of the largest floods on record and caused large amounts of bank erosion. The flood stripped most of the vegetation from the channel. The photo in 1978 shows the channel flowing almost full and there is a side channel that formed on the west side of the river near cross section 6.3447. In 2001, the channel is still mostly clear of vegetation. The channel has begun to erode the east bank near the proposed location of the wells. In 2005, the erosion near the wells has accelerated and the east bank just upstream of the upstream well is eroding. This erosion will likely continue in the future and would expose the well to river flows if left unprotected.

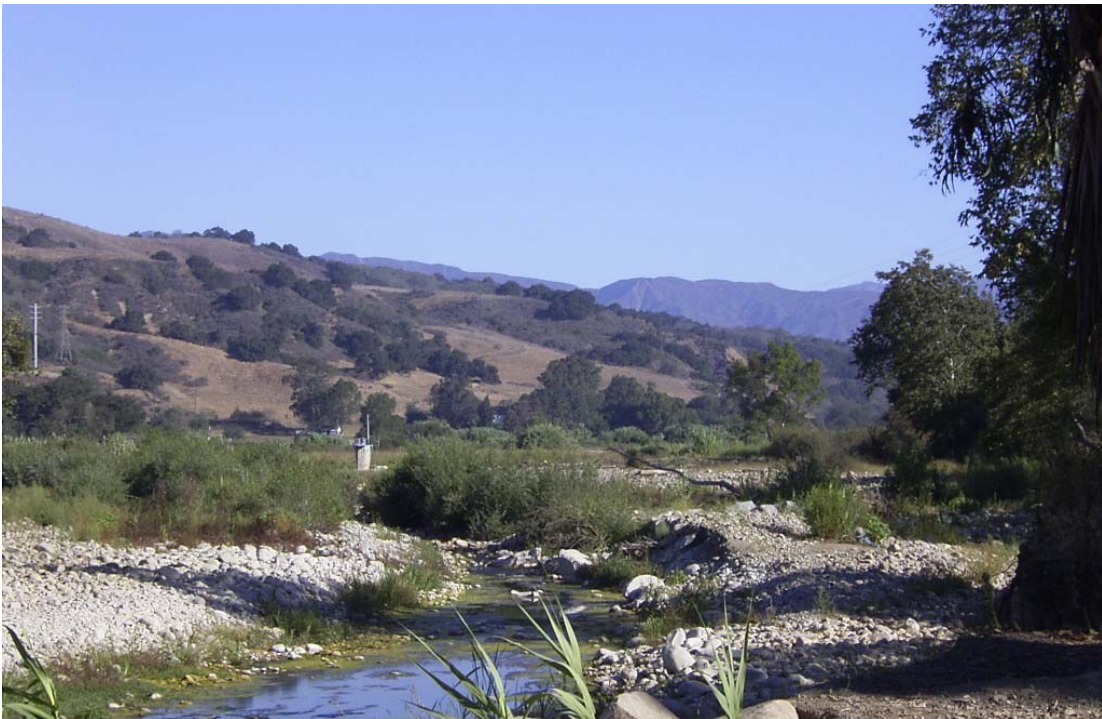
Figure 9. Picture looking Upstream from Upstream Well.

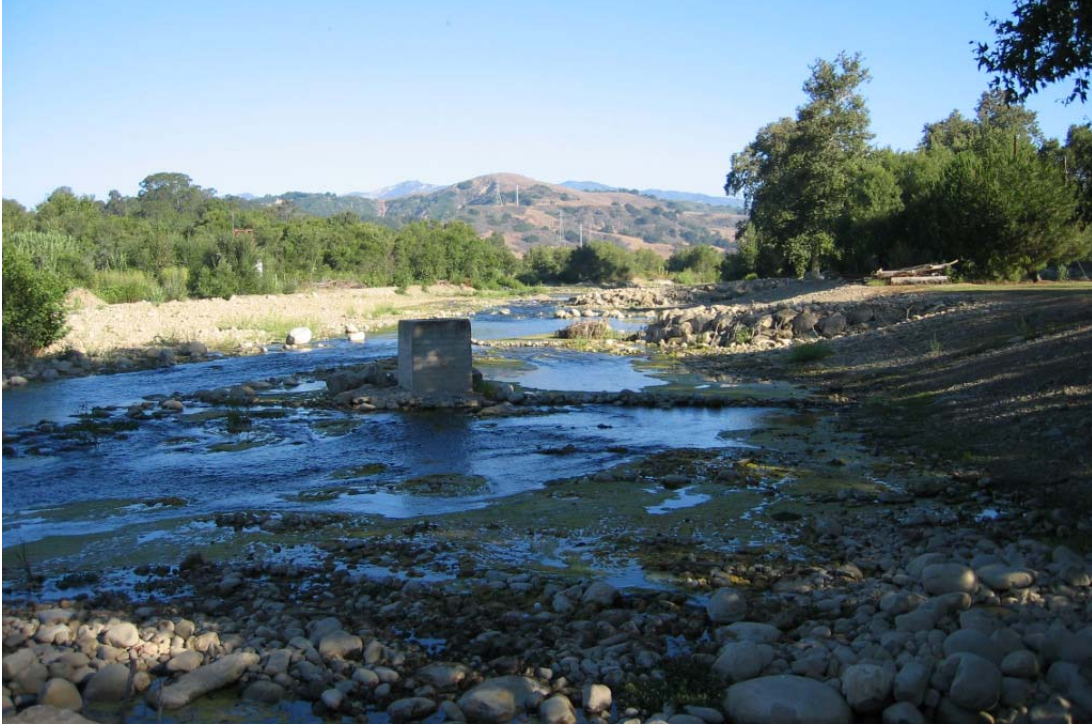
Figure 10. Picture Downstream of Proposed Well Locations Looking Upstream. Groins are Seen Along the Left Bank. The Concrete Structure is an Existing Well Operated by City of Ventura.

Several rock groin structures were installed in 2005 in the Ventura on the east side of river downstream of the proposed well location to protect Foster Park from erosion. These groins may protect the park from future erosion, but we did not perform an analysis to determine if the rock size was sufficient to stabilize the bank.

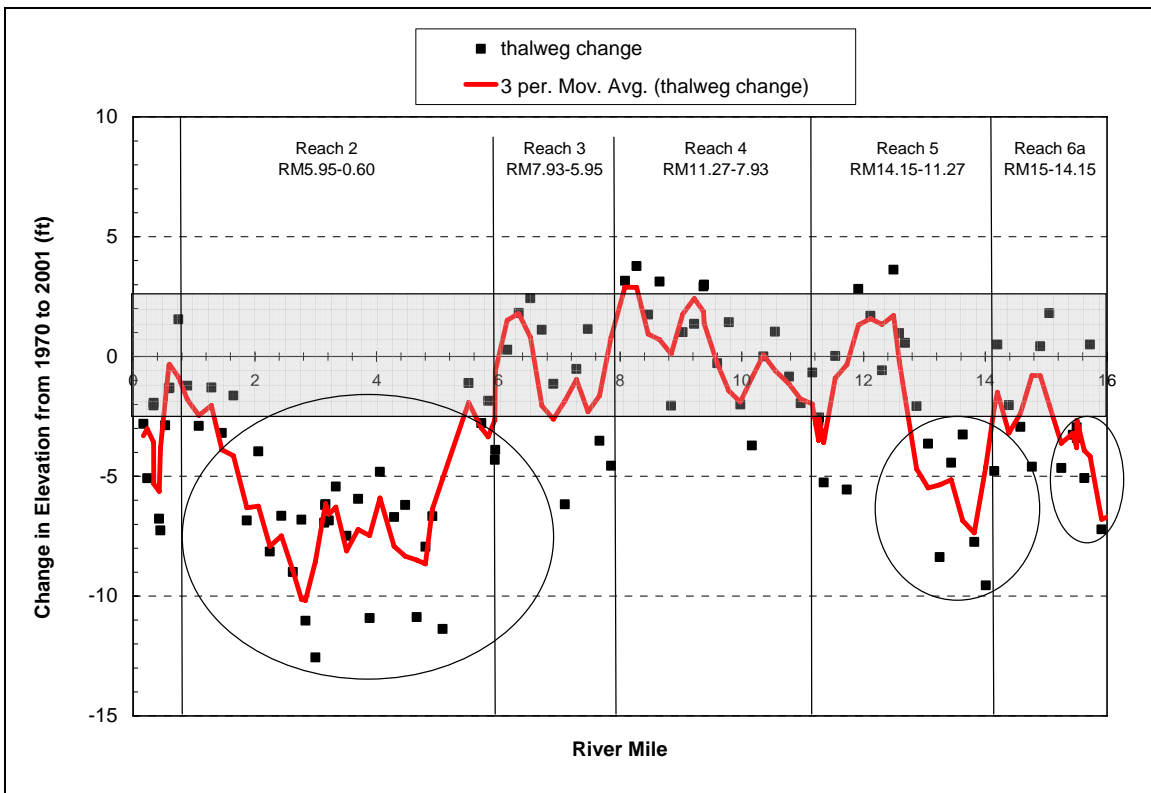
The elevations in the reach have remained relatively stable since 1970. Figure 11 shows the change to the thalweg elevations from 1970 to 2001. From RM 7 to 6 there has been less than 2.5 feet of change. A difference of less than 2.5 feet is not considered significant because the accuracy of the 1970 survey is estimated to be +/- 2 feet and it was not possible to exactly locate the 1970 cross sections.

Figure 11. Comparison of change in thalweg elevation between 2001 and 1970. Negative changes indicate areas of degradation in the channel bed. Positive changes indicate areas that have aggraded. Areas within 2.5 feet of change are considered to be within the error range of the 1970 data.

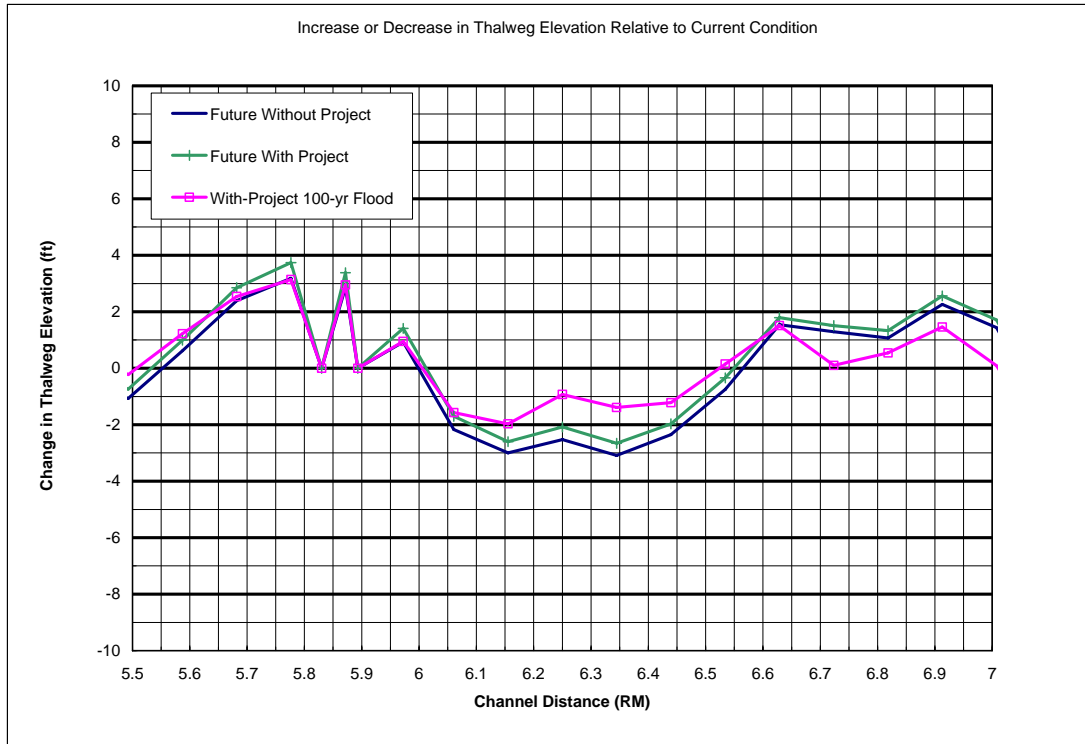
Figure 12. Change in Thalweg Elevation Relative to Current Condition.

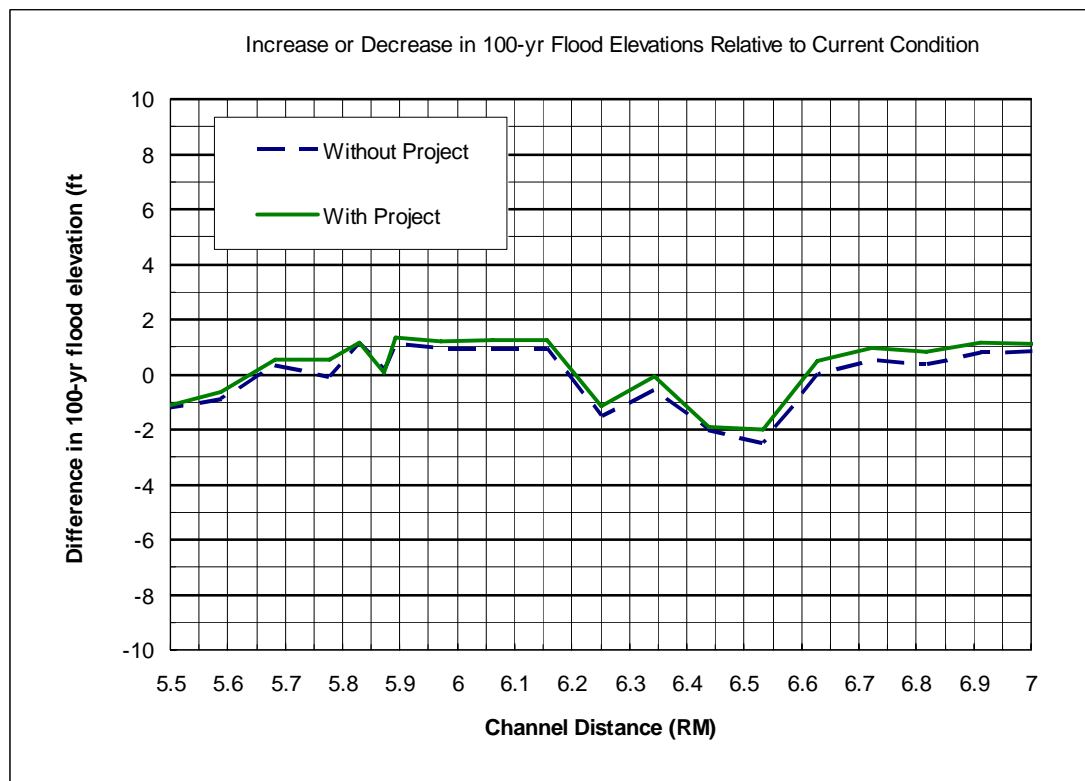
Figure 13 shows the predicted 100-yr water surface elevations under With- and Without-Project Conditions. The changes to the 100-yr water surface elevations generally follow the same trend as the thalweg changes, however, the magnitude of the change is generally less. From RM 6.4 to 6.2, the 100-yr water surface elevation is expected to decrease 1 to 2 feet. From RM 6.1 to 5.8, the 100-yr water surface elevation is expected to increase approximately 1 foot. These are both relatively small changes given the uncertainties in the sediment model.

Figure 13. Change in 100-yr Flood Elevations Relative to Current Conditions.

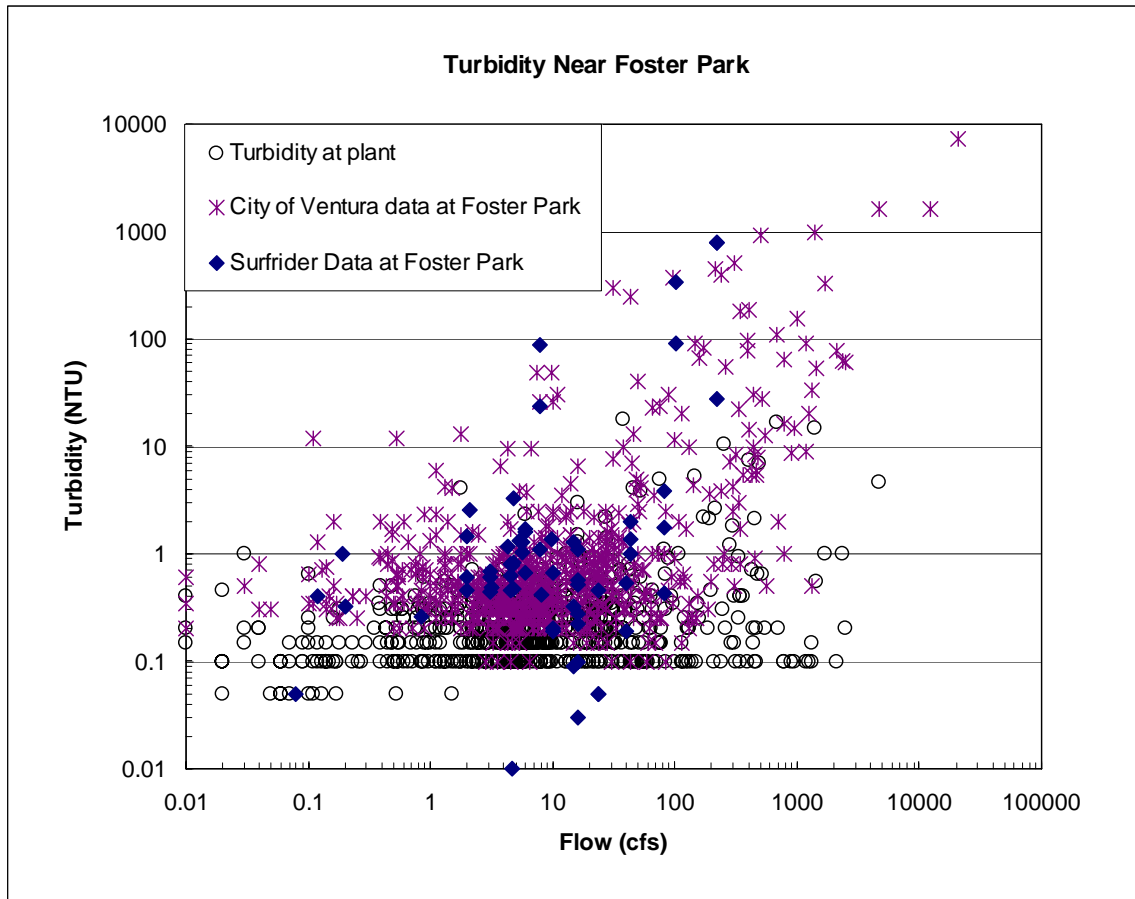
Figure 14. Current Turbidity and Sediment Concentration in the Ventura River at Foster Park.

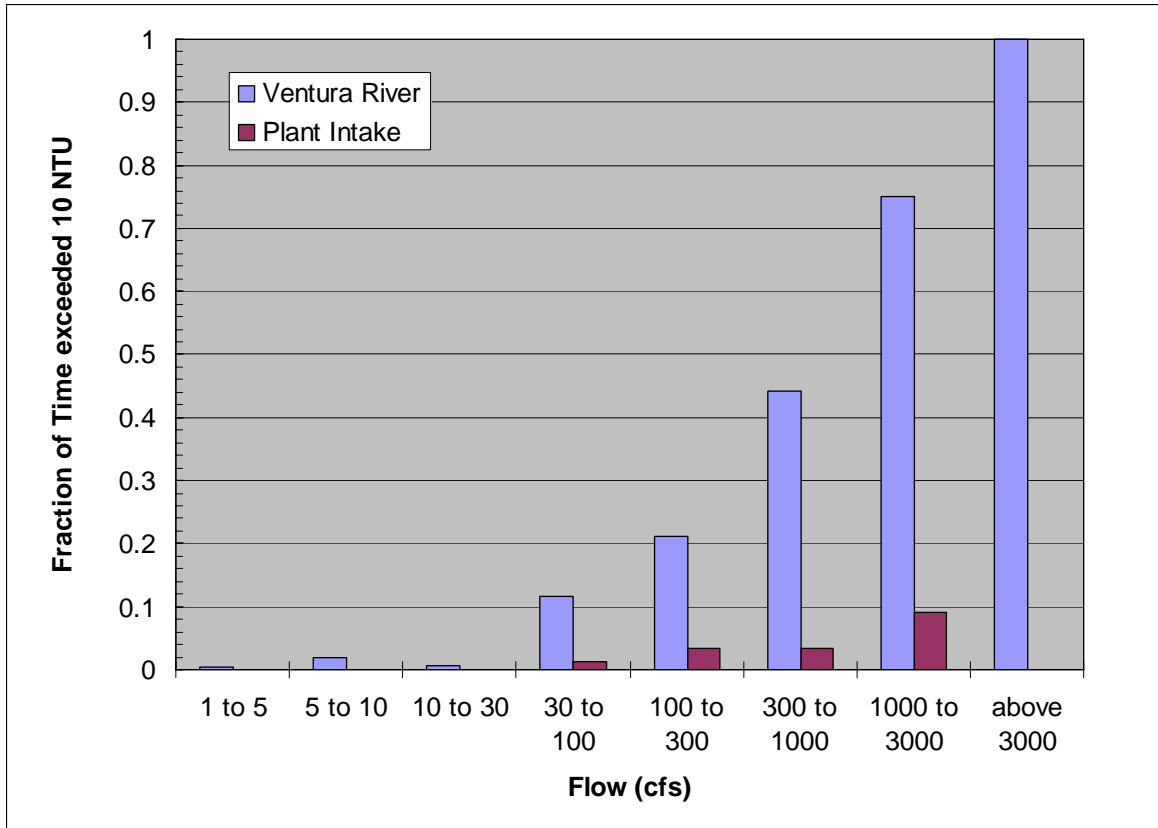
Figure 15. Fraction of Time 10 NTU Criteria is Exceeded in Ventura River and at City of Ventura Water Treatment Plant Intake under Without Project Conditions.

The City of Ventura presently discontinues surface diversion when the turbidity rises above 10 NTU in the Ventura River. The data from flow duration curve was used along with Figure 15 to compute the total fraction of time the City of Ventura Water Treatment Plant cannot divert from its surface diversion. The computation is shown in Table 9. Under current conditions and for the average year, the surface diversion is shut down approximately 4.6% of the time, or about 17 days per year on average.

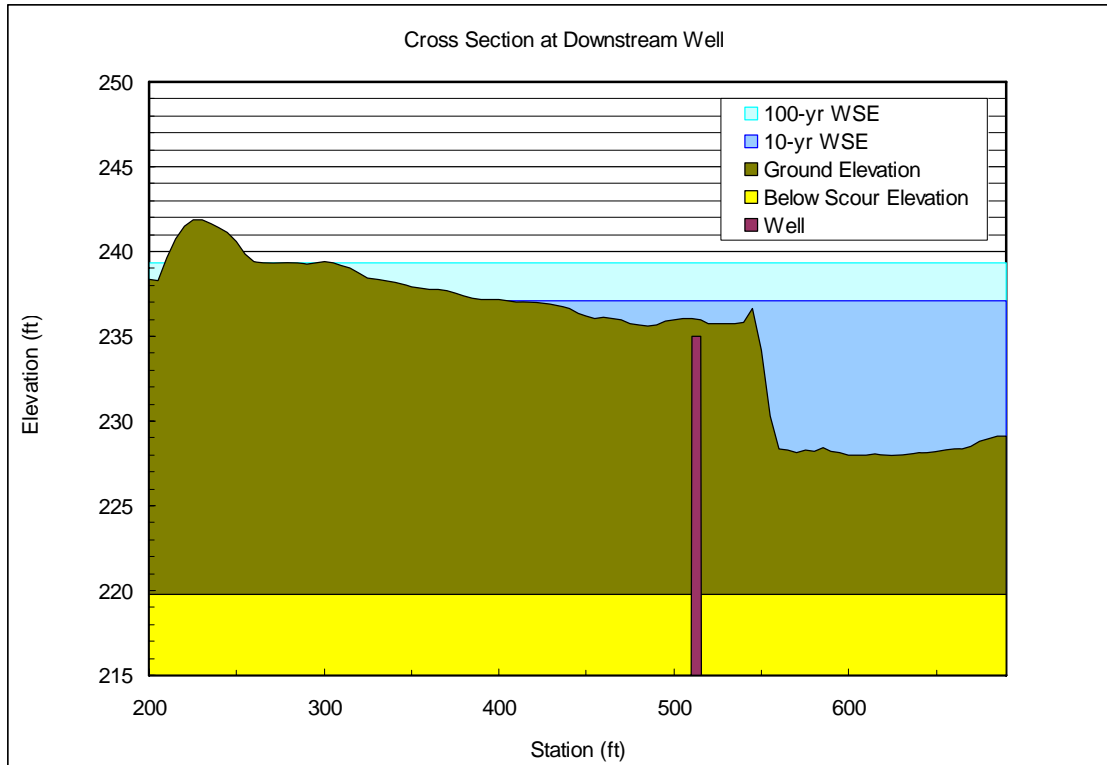
Figure 17. Close up of Cross section at Downstream Well.

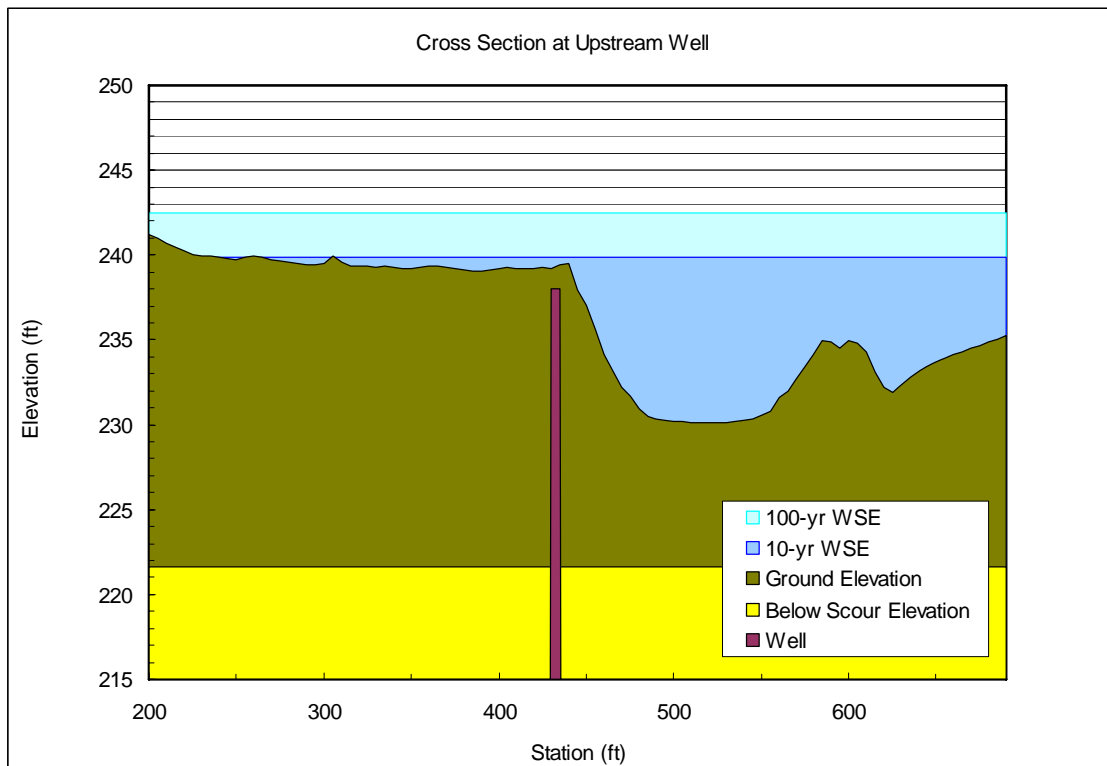
Figure 18. Close up of Cross Section at Upstream Well.
